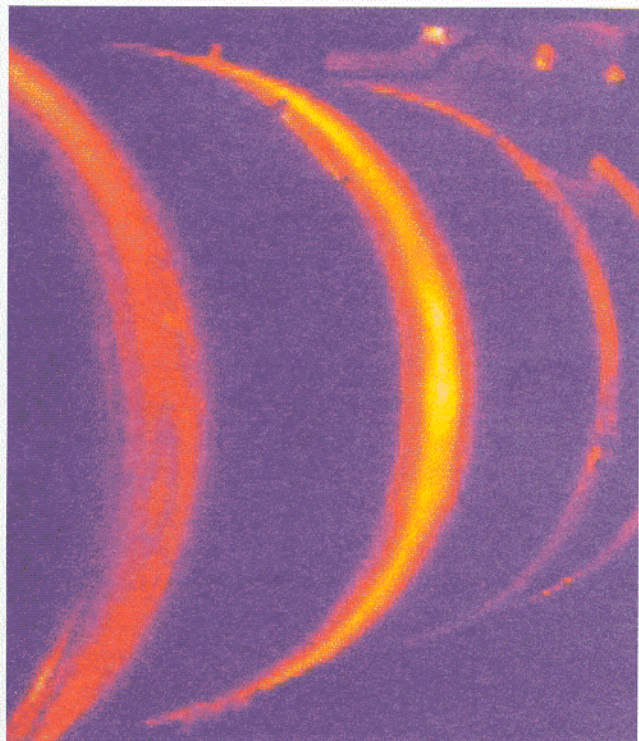
The thermophoto of the exhaust manifold of the main engine shows a maximum temperature of 250°C. The manifold should be checked for exhaust leakages and the insulation should be improved upon.
